EXHIBIT P

Degradation of polypropylene in vivo: A microscopic analysis of meshes explanted from patients

Vladimir V. lakovlev, 1 Scott A. Guelcher, 2 Robert Bendavid3

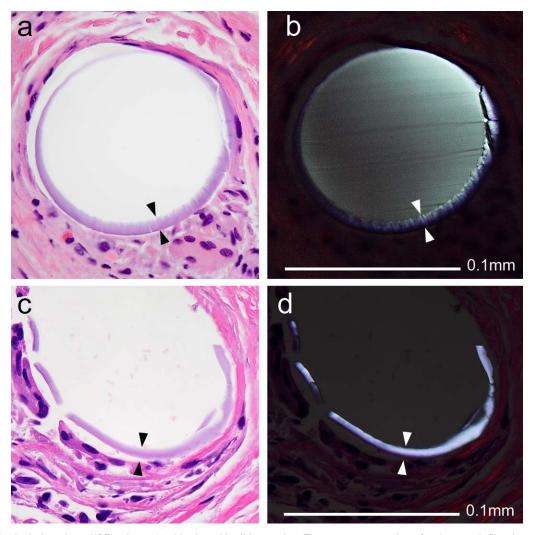
The degradation layer was detectable as a rim of purple material in the H&E stained sections while the central core of the fibers remained clear and colorless (except manufacturer's dye). The layer also showed variable staining by other histological stains indicating non-specific trapping of the dyes by

FIGURE 2. Histological sections, H&E stain, ×100 objective with oil immersion. The same cross section of a clear mesh fiber in regular (a) and polarized (b) light. The fiber has a layer of staining degraded polypropylene at the surface (between arrowheads). This layer has refractile properties of polypropylene in polarized light (b). In some areas the non-degraded core of the fibers detaches during histological processing while segments of the degraded layer stay attached to the tissue. Separated degradation layer in regular (c) and polarized (d) light. At sites like this, intensity of light passing through the degraded layer cannot be attributed to light scatter from the core. Note that tissue components including collagen have a much weaker birefringence than polypropylene (b and d). [Color figure can be viewed in the online issue, which is available at wileyonlinelibrary.com.]

polypropylene. In polarized light, both the central core of the fibers and the outer layer showed similar refractile properties [Figure 2(b)]. The light intensity was uniform within the core while the outer layer had gradual reduction of the refractile ability toward the surface. Birefringence of the outer layer was also observed in the segments of the "bark" separated from the core [Figure 2(c,d)]. At these sites, the light brightness in the "bark" layer was due to its internal properties and could not be attributed to the scatter of light from the core. The adjacent tissue components containing collagen also showed birefringence, however of a much lower intensity. The tissue components also had a different structure and coloration.

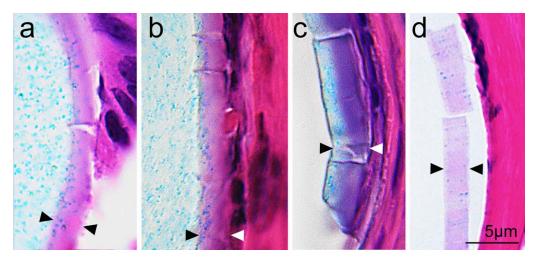
FIGURE 3. Degradation "bark" of the blue fibers manufactured with inclusion of blue dye granules, H&E stain, ×100 objective with oil immersion: (a) and (b) non-degraded core (left half of the images) and the degraded layer (between arrowheads). Note that the blue granules are retained in the layer of degraded polypropylene. Within the degraded "bark," the granules degrade and loose color toward the surface. In (c) and (d) the non-degraded core detached from the slides similarly to Figure 2(c,d). At these sites, presence of the granules in the separated "bark" cannot be attributed to an overlap with the core. [Color figure can be viewed in the online issue, which is available at wileyonlinelibrary. com.]

into the material during its manufacture (Figure 3). The granules were seen in the non-degraded core of the fibers as well as to a variable degree in the outer degradation layer. In the latter, they were detected within the "bark" remaining on the core [Figure 3(a,b)] as well as in the segments of the "bark" separated from the core [Figure 3(c,d)]. The granules were mainly seen in the deeper layers of the "bark" and were not as frequent closer to the surface, which suggests that they also undergo degradation and lose color. The finding was a direct confirmation that the "bark" originated from the same material as the core of the fibers.

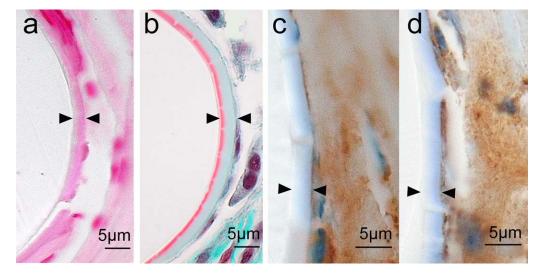
The brittleness, staining and birefringence characteristics of the "bark" were similar to those of calcium salts which are commonly deposited in degenerating tissues. Von Kossa stain was used for a sample set of 10 specimens to rule out presence of calcium salts in the outer "bark." No calcium salts were detected in the brittle outer layer of the 10 specimens tested [Figure 4(a)].

FIGURE 4. Additional stains, all images taken with 100x oil immersion objective and cropped to a different magnification, polypropylene degradation layer is pointed between arrowheads: (a) Von Kossa stain is negative for calcium in the brittle "bark" (would stain calcium black), (b) trichrome stain shows that the deeper parts of the "bark" have smaller staining porosity (red) than those close to the surface (green) which correlates with TEM findings [Figure 6(b)], (c) immunohistochemical stain for immunoglobulin G (lgG, stained brown). IgG is present in almost all human tissues and fluids. It is deposited on the surface of degraded polypropylene but is not mixed within it. (d) Immunostain for the oxidizing enzyme of inflammatory cells myeloperoxidase (stains brown). [Color figure can be viewed in the online issue, which is available at wileyonlinelibrary.com.]

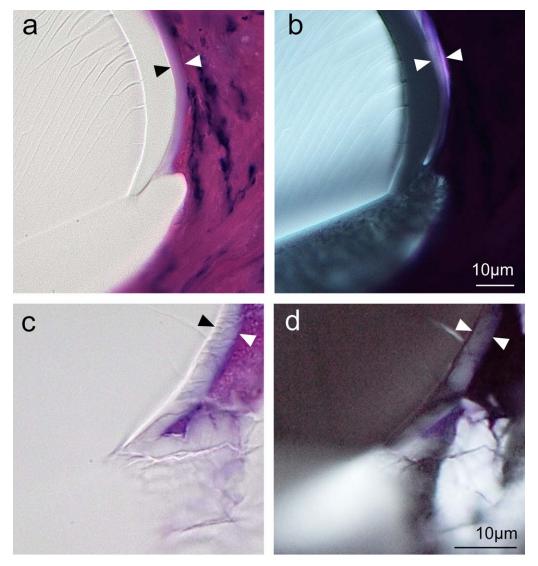
Surgical cautery instruments cause heating of the tissues to a wide range of temperatures. There is usually a narrow zone of high temperature immediately at the tip of the instruments with a sharp drop in temperature in the deeper tissue further away. In excised specimens cautery changes (darkening and nuclear streaming) are seen within 1-2 mm from the cauterized surface. In these areas, mesh fibers showed sites where both the outer degraded polypropylene "bark" phase and the inner non-degraded polypropylene phase melted and mixed to form a single homogeneous phase (Figure 5). The phase-mixed regions did not absorb histological dyes, thereby showing that they lack porosity observed in the degraded polypropylene. The fact that the "bark" was melted during excision surgery indicated that the degradation layer was formed in the body before the excision surgery. The finding also revealed that the fiber core and the outer "bark" are composed of materials with similar chemical compositions that are miscible with each other when heated.

FIGURE 5. Melting of both non-degraded and degraded polypropylene caused by the surgical cautery, H&E, ×100 oil immersion: (a) and (b) the same site of fiber melting in regular and polarized light, (c) and (d) another site showing melding point. While molten the non-degraded core and the degradation "bark" formed a common pool of material. [Color figure can be viewed in the online issue, which is available at wileyonlinelibrary.com.]

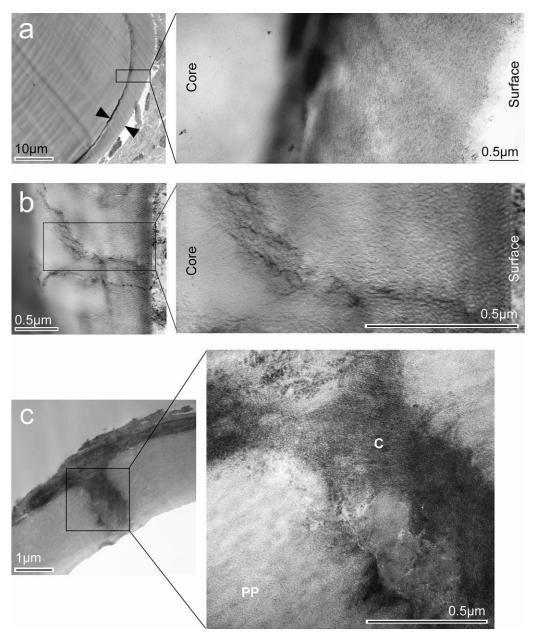
We used TEM to study the ultrastructural organisation of the degraded layer in cross sections. The mesh fibers showed an outer "bark" similar to that seen by light microscopy [Figure 6(a)]. There were no fibrillary (collagen, amyloid etc.) or other structures of connective tissue matrix within the "bark". Material composition of the outer layer and the core showed similar electron density; however, at high magnification the outer "bark" was noticeably more granular, especially toward the surface [Figure 6(a), insert].

The "bark" material had a lattice of fine branching cracks (nanocracks). This network of nanocracks was sparse closer to the core and expanded toward the surface [Figure 6(b)]. As seen in Figure 6(b) in addition to the nanocracks there were also occasional larger cracks occurring at random. These larger cracks seen by TEM corresponded to the cracks seen by light microscopy either on the surface (Figure 1) or in cross sections (Figure 2).

The "bark" either had a gradual transition into the core [Figure 6(b)] or showed a zone of circumferential fissuring partially separating it from the core [Figure 6(a)]. The mechanisms of "bark" separation from the core and formation of the larger cracks are likely linked since the cracks tended to turn at the interface between the "bark" and the core [Figure 6(b)]. The forces which produced the transverse (radial) cracks also acted as shear forces between the "bark" and the core.

An important finding was the detection of inflammatory cells partially migrated into and trapped within the fissures as shown in Figure 6(c). The shape of widened crevices and the depth of penetration indicated an active *in vivo* cellular migration. This phenomenon was observed at two separate sites.

FIGURE 6. Transmission electron microscopy. (a) Low power magnification of a cross-sectioned mesh fiber shows the degradation layer similarly to light microscopy, the insert shows an image composed of three high power fields to reconstruct the transition between the non-degraded core and the degradation "bark." Note the fine nanocracks/nanopores in the degraded material. (b) Outer part of the fiber with gradual transition between the non-degraded core and the degraded polypropylene at the surface. The lattice of nanocracks expands toward the surface (left to right). There are also two larger cracks which start perpendicular to the surface but then turn at the interface between the core and the degraded layer. (c) A part of inflammatory cell (labeled C in insert) is trapped in a fissure within the degraded polypropylene (PP). Higher magnification (insert) shows cellular membrane at the cell-polypropylene interface (left wall of the fissure) and cellular organelles in the cell (chains of rounded structures, likely ribosomes).

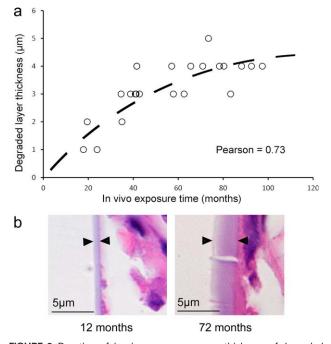
Out of all the specimens, 23 samples of explanted midure-thral slings formed the largest group of meshes from the same manufacturer, of identical mesh type and with reliable records of implantation and excision dates. The range of in vivo interval (between implantation to excision) in the group was 18-97 months (mean 53). There was a good correlation (Pearson = 0.73) between the thickness of the degradation layer and the duration of in vivo exposure indicating that the thickness of degraded material grows while the mesh is in the body [Figure 8(a,b)]. There was a trend for a more rapid initial growth with gradual plateau subsequently.

FIGURE 8. Duration of *in vivo* exposure versus thickness of degraded layer in a group of explants of the same manufacturer and the same mesh design. (a) Thickness of the degradation "bark" increased over the years *in vivo* (Pearson correlation = 0.73). Note the trend of plateauing after 5–6 years. There was no correlation of the thickness with the duration of specimen storage in formalin (not shown, Pearson = -0.06). (b) Comparison of the "bark" in meshes explanted after 12 and 72 months in the body, H&E, \times 100 objective with oil immersion, images cropped to the same magnification factor. [Color figure can be viewed in the online issue, which is available at wileyonlinelibrary.com.]
